Intel® Mobile Celeron™ Processor Specification Update

Release Date: May 1999

Order Number: 244444-004

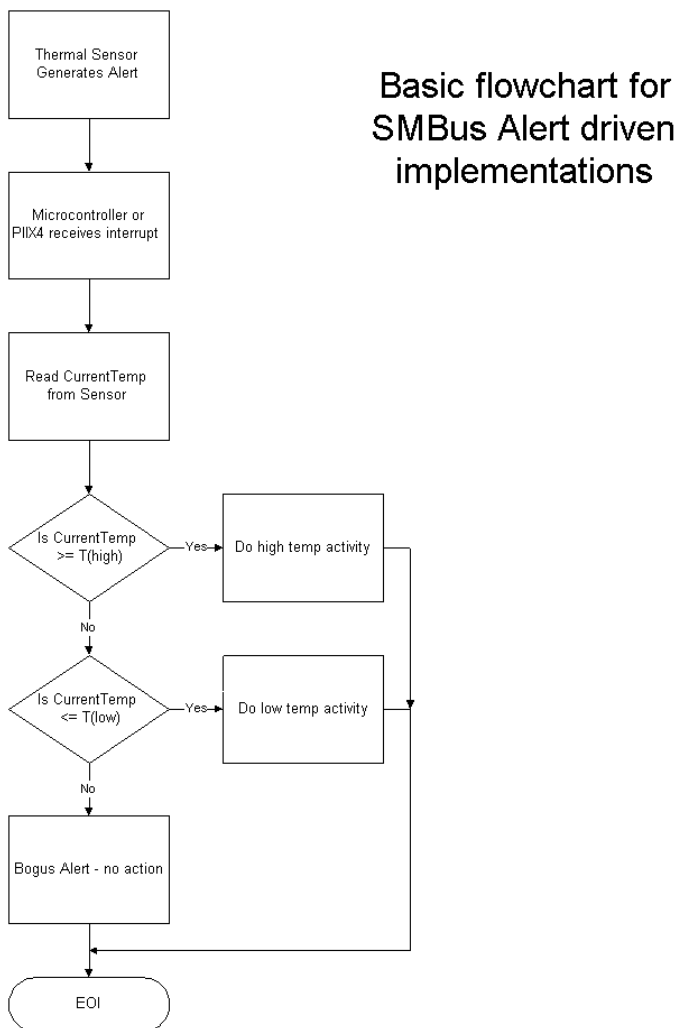
Figure 2. Workaround Flowchart: SMBALERT#-Driven System

Under the conditions described below, the thermal sensor incorrectly generates the SMBALERT# interrupt. *All* of the following conditions must be met to trigger a false interrupt:

WORKAROUND: Three different (mutually exclusive) workarounds are possible:

1. Before servicing an interrupt from the thermal sensor, read and compare the processor thermal reading with the threshold limits (T_{HIGH} or T_{LOW}). Figures 2 and 3 provide basic flowcharts for the implementation of this workaround in an interrupt driven system.
2. If the firmware implemented polls the Status Register only, then before taking any action, re-read the temperature register and do a comparison with the alarm threshold limits (T_{HIGH} or T_{LOW}) to determine if the value is actually still within the temperature window.
3. Use a temperature polling scheme to monitor the processor temperature.
